June 1980

DCIEM Technical Communication No. 80-E-30

OCCUPATIONAL
HEALTH
EVALUATION
FOR
INORGANIC MERCURY
AT
CFB BORDEN - BUILDING A-171,

B.J./Gill
J.L./O'Neill
Health Sciences Section
Biosciences Division

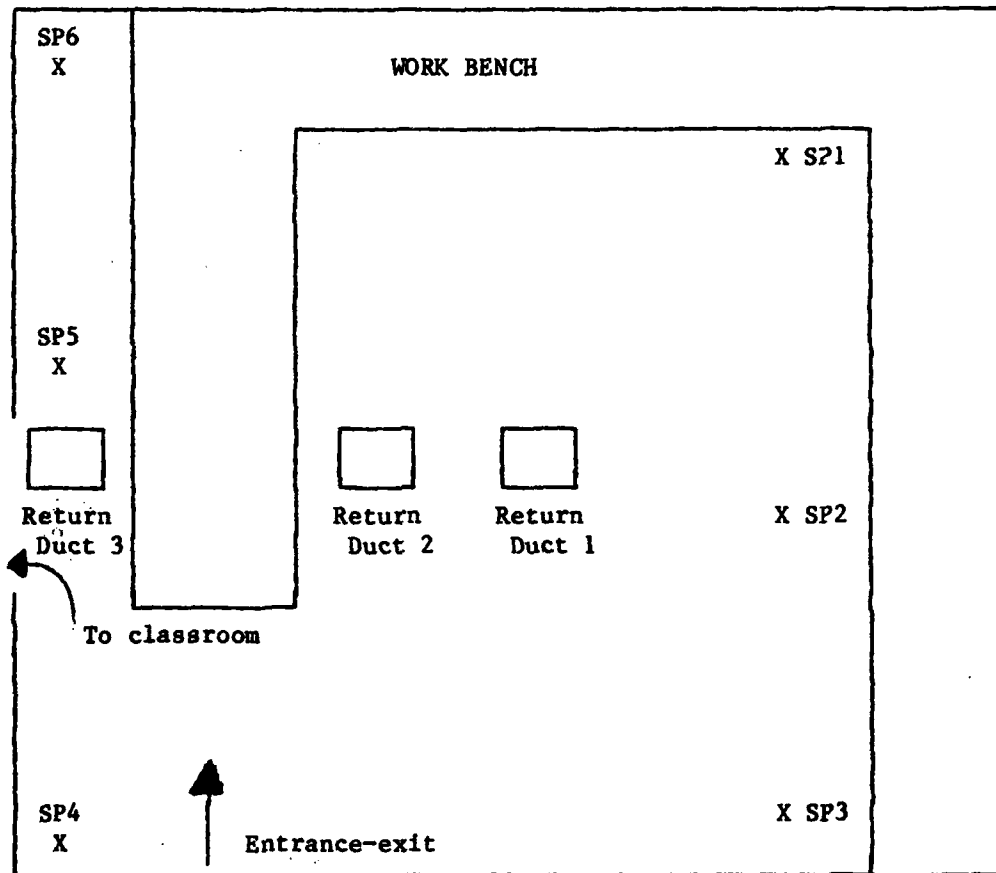
Figure 1
Room 117A - Aircraft Instrument Laboratory

At the time of the survey, Rooms 117A and 117B were being used as an Aircraft Instrument Laboratory and Classroom facility respectively. Although mercury had not been used in Room 117B, monitoring was carried out in this room because of its close proximity to the main calibration laboratory. Spot sampling readings of Room 117A were taken as indicated in Figure 1 which also shows approximate laboratory dimensions and the location of mercury-containing calibration instruments.

Results obtained from the two days of spot monitoring in Room 117A are shown in Table 1. Further clean-up of areas in which elevated readings were obtained took place prior to the readings obtained on Day 2. Cleaning was carried out by means of a commercially-available mercury spill kit. On the second day only one area (Duct 3) continued to provide readings approximately at the TLV level following extensive clean-up procedures. No hazardous levels of mercury vapour were detected in Room 117B.

Spot sampling in the vicinity of Duct 3 continued to give a mean value at the TLV level. Further clean-up is required in this area to reduce the level to below the recommended standard.

Sampling Points	Day 1	Day 2
1	<0.005	<0.005
2	<0.005	<0.005
3	<0.005	<0.005
4	<0.005	<0.005
5	0.04 - 0.10	0.02
6	0.08 - 0.10	0.02
Return Ducts		
1	0.02	0.02
2	0.04	0.02
3	0.04 - 0.10	0.04 - 0.06
